**South Eastern Railway**

**No. PCEE/RS/268/Misc./26/105**

**Subject:** Additional Troubleshooting for WAP-7 Locomotives Working with HOG.  
**Ref.:** OPR of Loco No. 39224/WAP-7/SRCE dated 01.09.2026

### Failure Report:

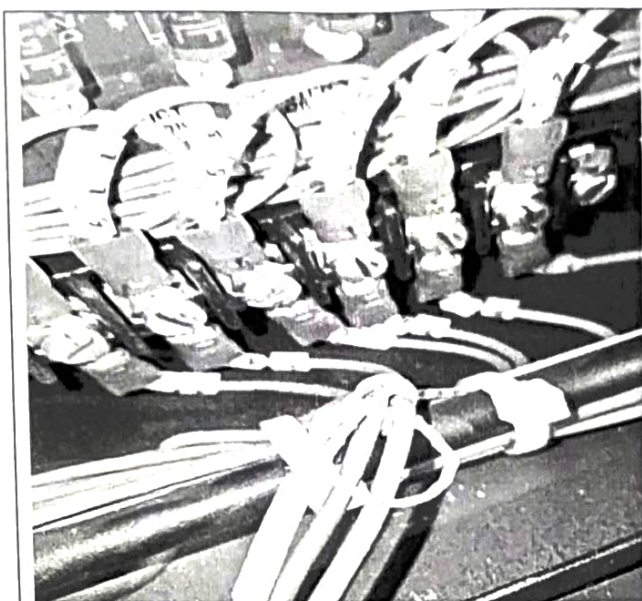
- Loco further checked on 02/09/26 by FTIL firm representative, SSE/ELS and SSE/OP.
- In pneumatic panel, Positive cables **16B** and **57A** found pressed and punctured at snubber circuit PCB board.
- Cab1 LP side HOG IV coupler **cap short link plate** for pin number 7&10 got earthed causing positive earth fault of HOG.
- Cab2 LP IV coupler cables pressed and insulation damage causing positive earth fault of HOG.

In pneumatic panel, Positive cables 16B and 57A are pressed and punctured at Snubber circuit PCB board.

- RDSO MS-488, Rev.1 dated 12.03.2026 to be completed in all HOG locos.
- One cycle checking of all cables and connectors of E70 brake system.

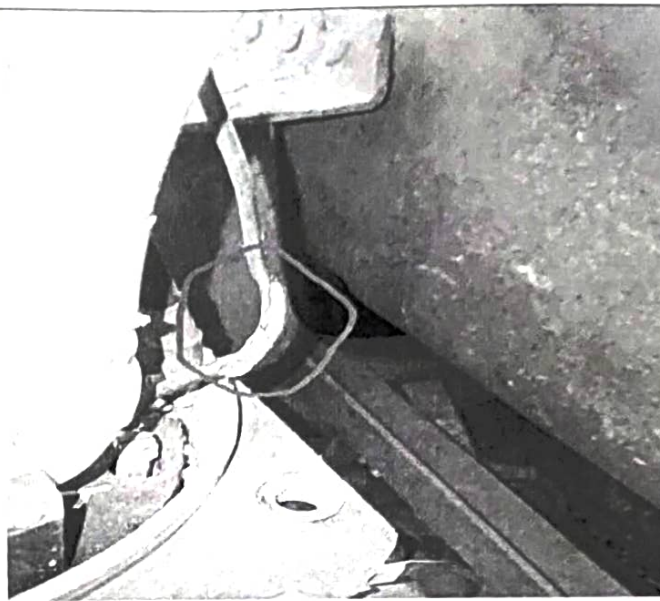
Cab2 LP IV coupler cables pressed and insulation damage causing positive earth fault of HOG

- The positive earth fault in the loco and negative earth fault associated with HOG Power Car No. 138853 resulted in tripping of MCB 127.7 (Brake Electronics Circuit) and consequent Brake Electronics Failure indication.

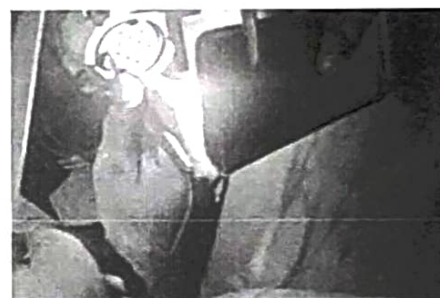
- Joint checking was done at VSKP on 02-09-26 between CLI/VSKP, SSE/OP/VSKP & JE/Elect/G/VSKP of Train No. 22842, Loco 37200/BZA, PC 138853. Train arrived on HOG working normal. After removing UIC, B-side fixed coupler Pin-12 of Power Car No. 138853 found permanently earthed (-ve). While A-side OK. **Loco display showed earth fault which vanished after removing UIC.** Rake previously worked with 39224/SRC (22841).

Power Car UIC Fixed Coupler  
Pin No. 12 Earthed
